Background info for boat repair discussion with Alex Conley ([conley.alex@gmail.com](mailto:conley.alex@gmail.com) or 509 654-0394)

Boat is 1986 Montgomery 15; known for high quality layups

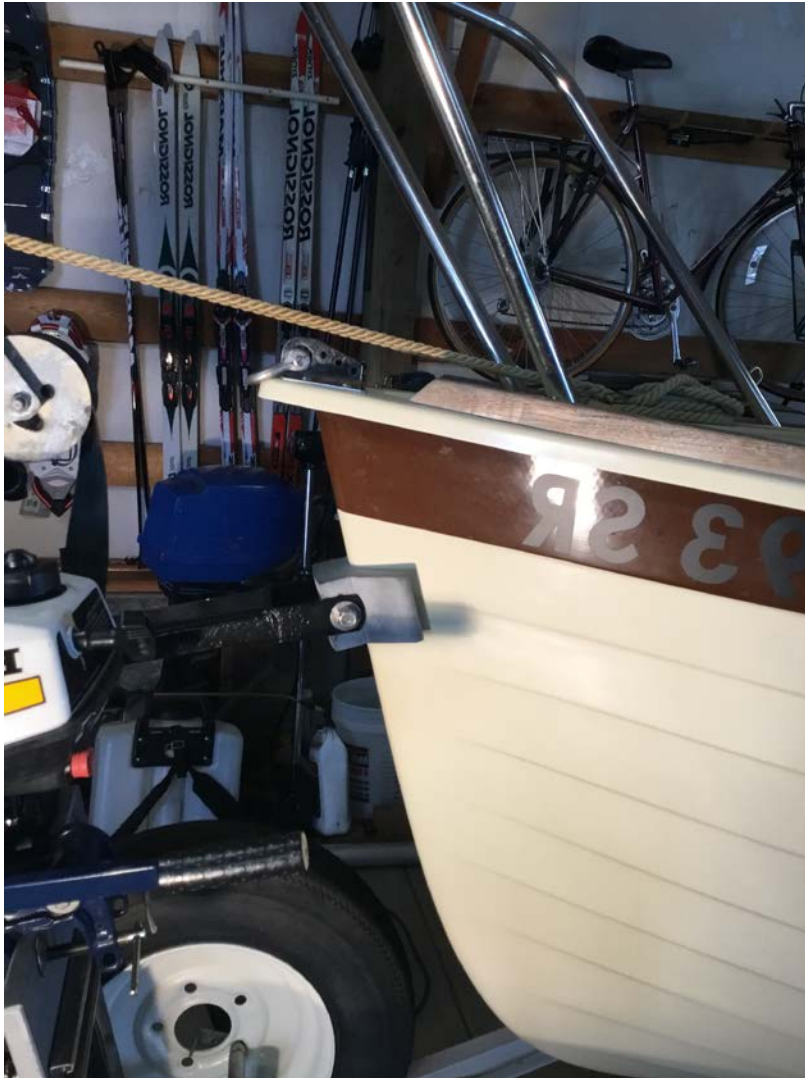
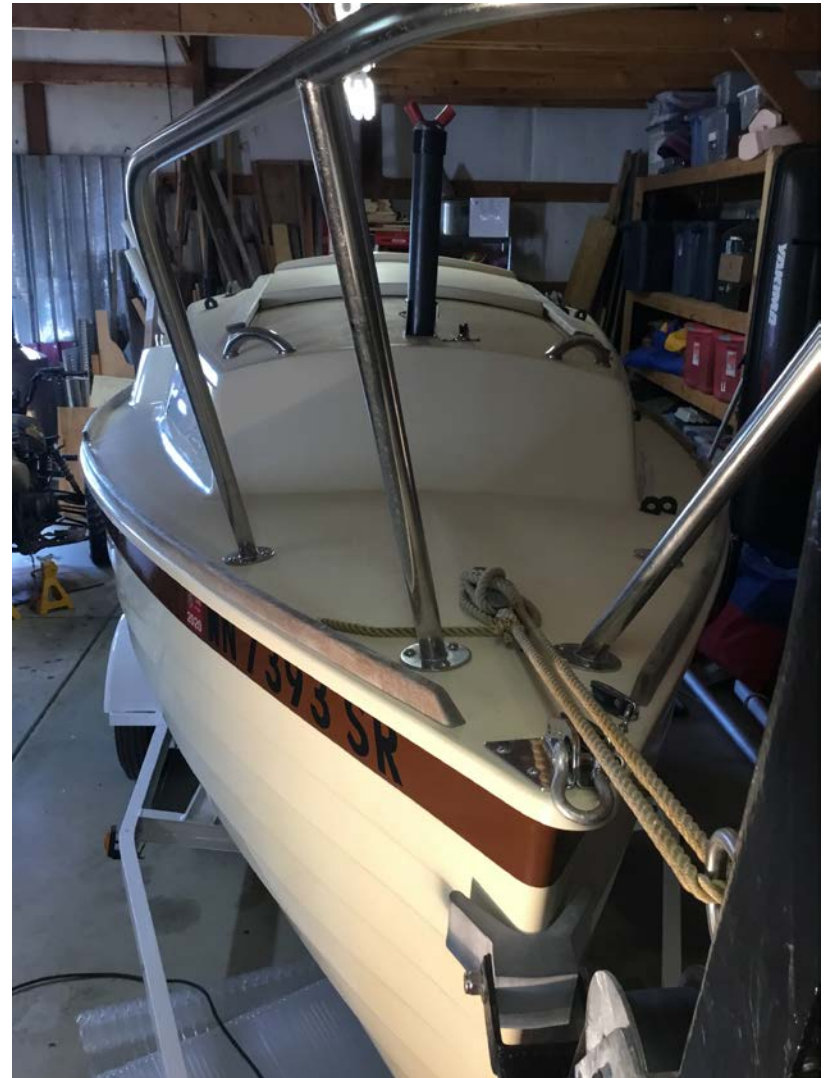
Bow fitting takes both upward pull from forestay and pull when used as eye for trailer winch strap, so crack repair needs to be structural sound

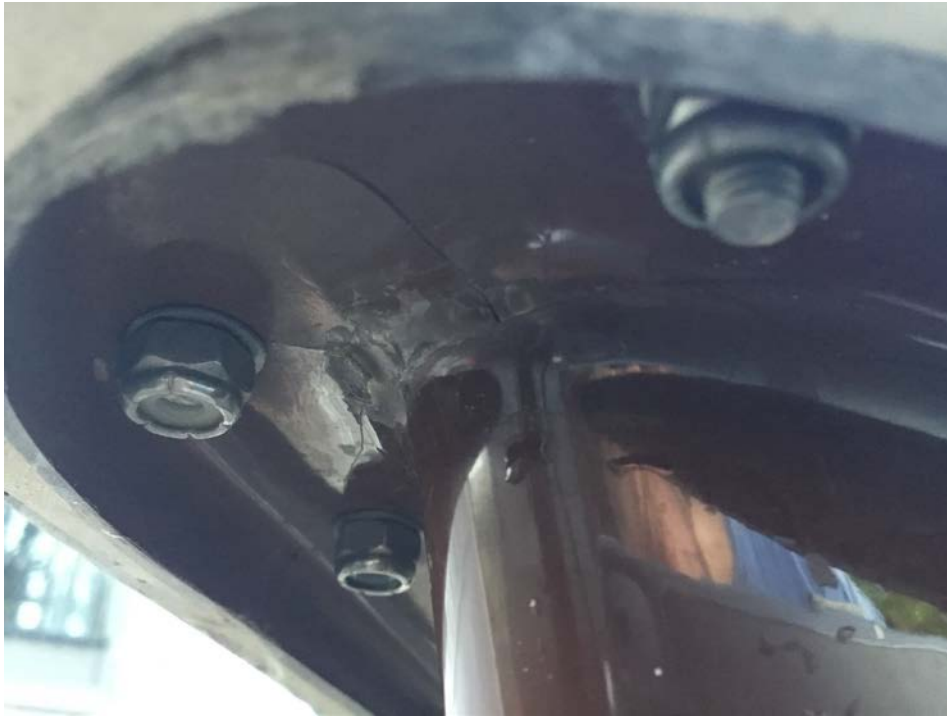
## Closeup of most extensive cracking in lip of hull

I'm guessing boat dropped and the bow overhang caught the fall (some damage to edge in out of focus upper left part of photo above)

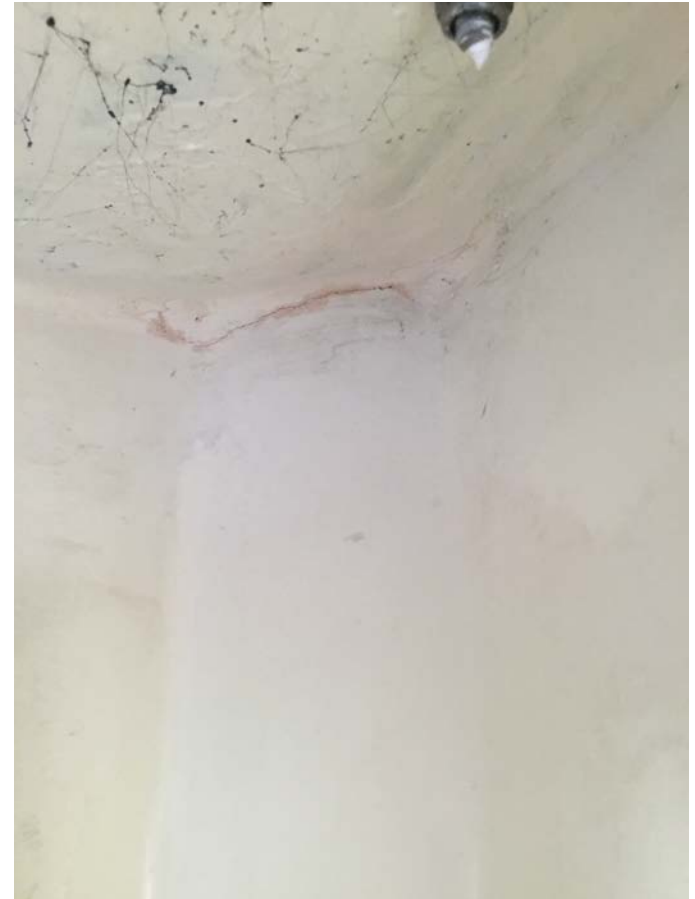
Interior view showing crack at hull liner/deck joint in bow; liner lightly bonded to hull sides, but void between stem and liner (see flat section of liner maybe 2-3" aft of very stem)

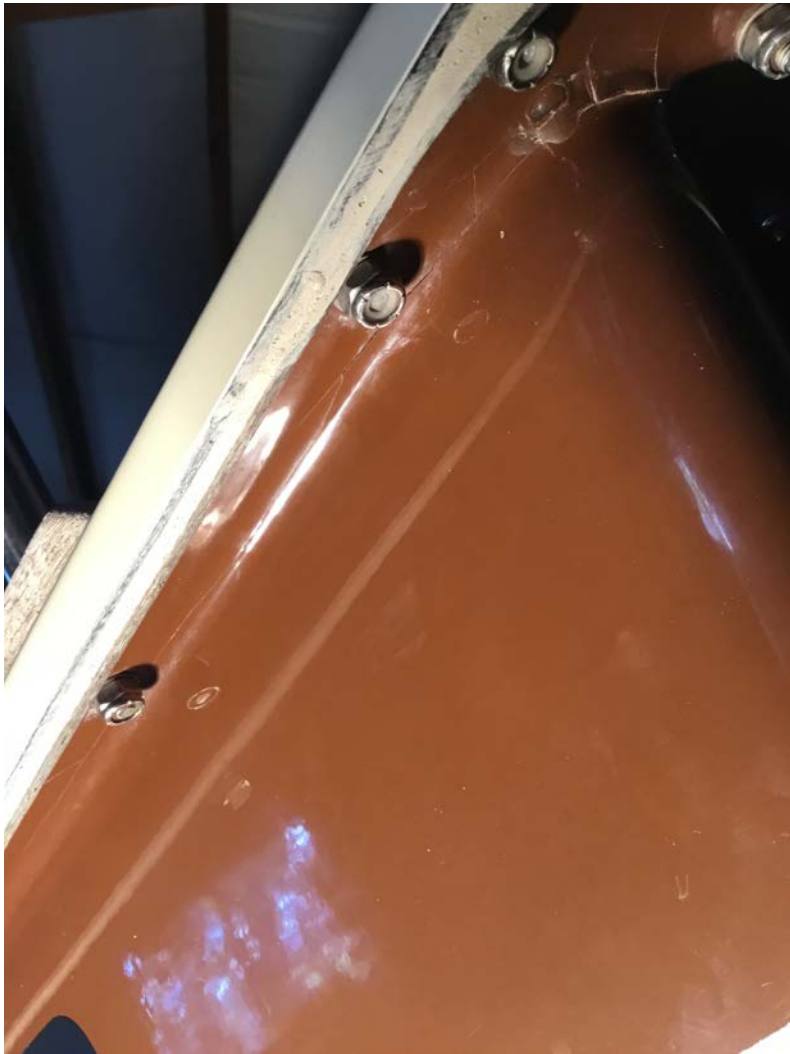
Starboard side crack extends ~9" aft (beyond last bolt)

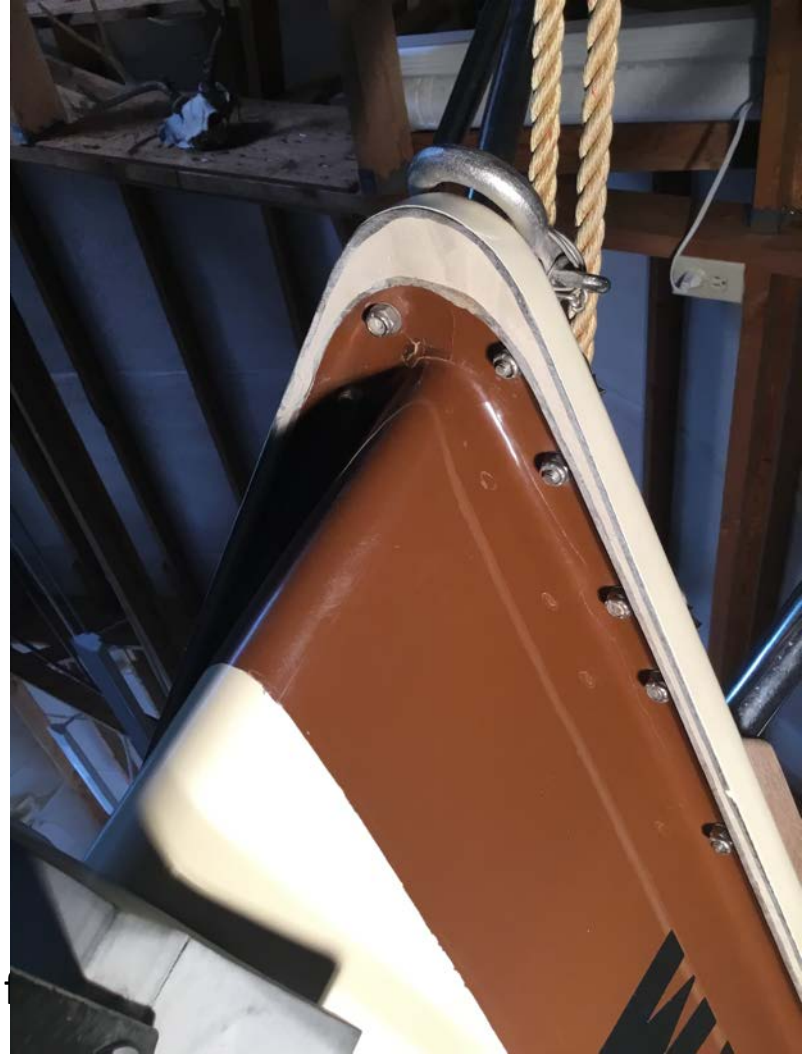
Portside crack extends ~8" aft (stops just before last bolt)

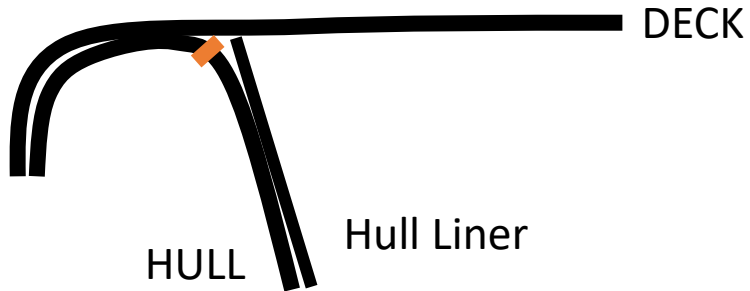
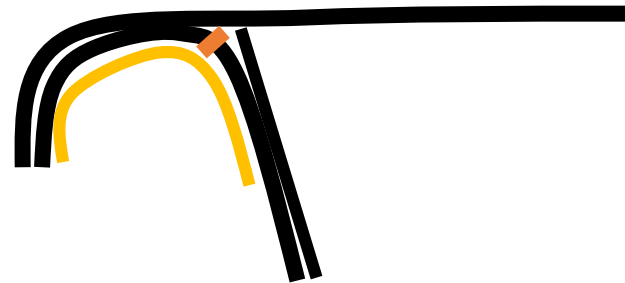
Existing condition- crack in red

A. Grind out crack & use gap filling epoxy (no glass reinforcement)
